Your survey and valuation report

100 Any Avenue, Northampton, Northants, NN10 1AB

1st July 2022

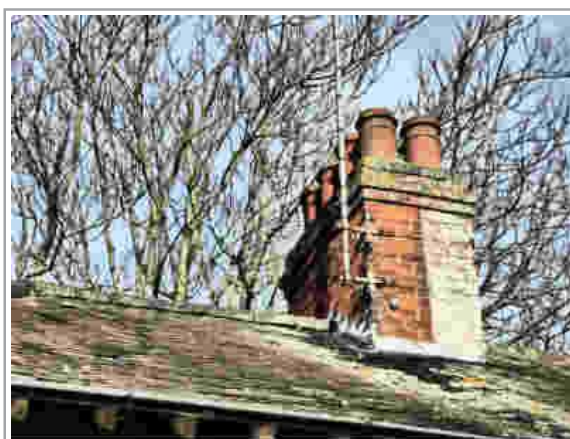
Chimney stack

Slight distortion caused by heat is apparent to the chimney stack. However, the chimney is considered to be stable and repair is not considered necessary, **Condition Rating - 1.**

As to be expected with mortar pointing in such an exposed location general weathering is evident. Attention to this considered to be normal maintenance. To repair/maintain chimney stacks safely, contractors may have to use appropriate access equipment (e. g. scaffolding, hydraulic platforms, etc). This can increase the cost of the work, **Condition Rating - 1.**

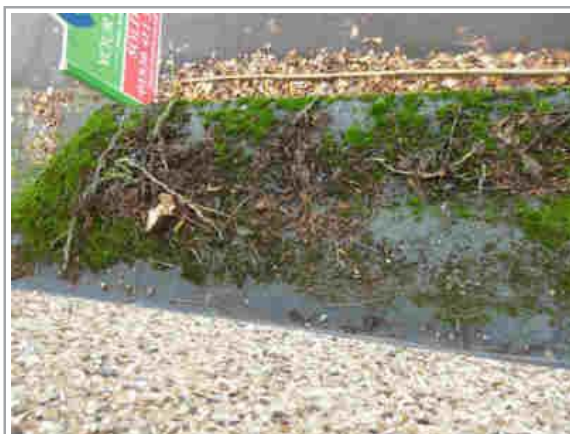
The flat roof to the bay window has leaked in the past. When tested with a moisture meter it was found to be dry however the replacement roof covering is some years old. You should budget to replace this in the short to medium term, **Condition Rating - 2.**

You should be aware that flat roof coverings have a limited life compared with sloping roofs. They demand a high degree of maintenance and failure can occur with little warning, **Condition Rating - 1.**

Felt roof covering to bay window from above

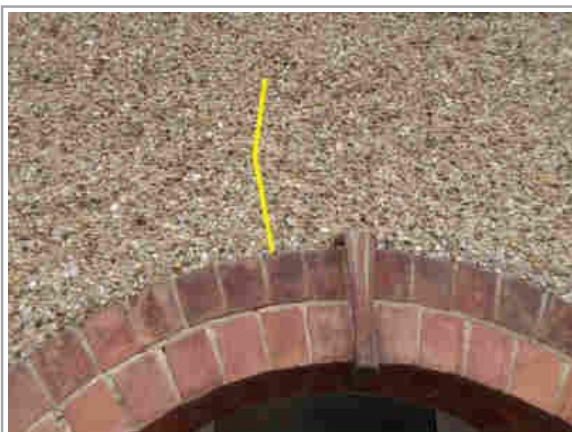
Parts of the render coating are cracked. Defects in the render coating can allow the rain into the wall and in the worse case, cause dampness internally. You should repair this soon. This is considered to be more than normal maintenance but is not serious or urgent, **Condition Rating - 2.**

Minor render crack above porch

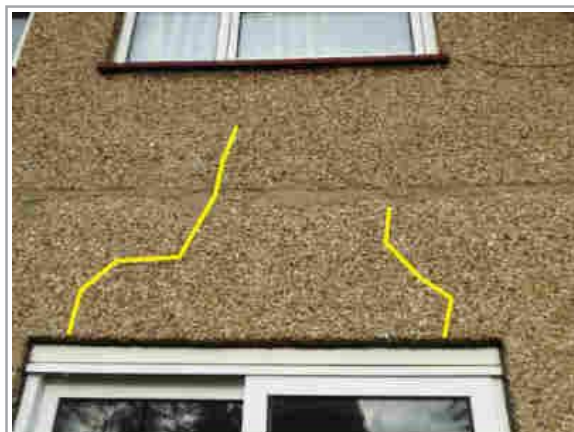
Render cracking to rear

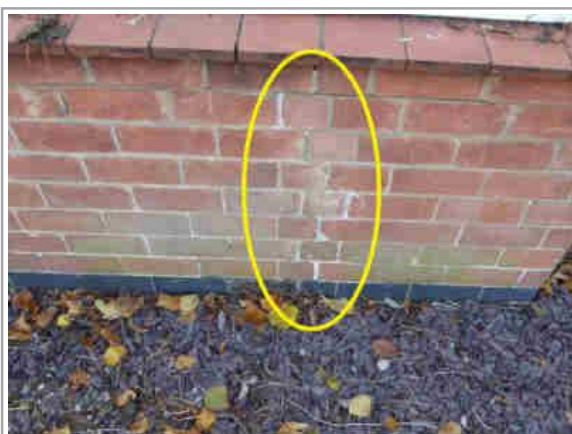
Slight stepped cracking is evident to the front bay brickwork. This is considered to be attributable to normal thermal movement and a minor defect which does not have any serious structural significance, **Condition Rating - 1.**

Cracking to bay window

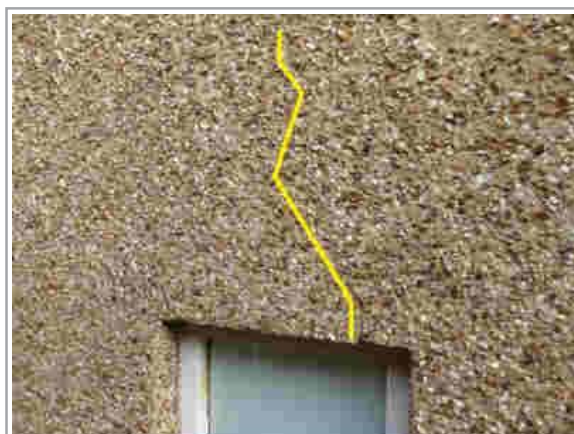
Cracking to right gable

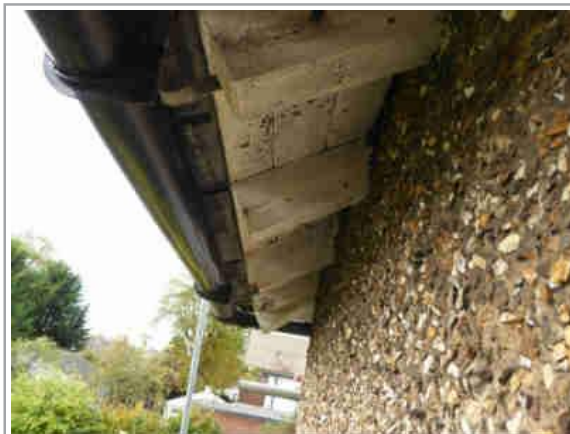
No serious defects or urgent repairs were observed but normal maintenance will be necessary,
Condition Rating - 1.

Redecorate rafter feet & soffits as normal maintenance

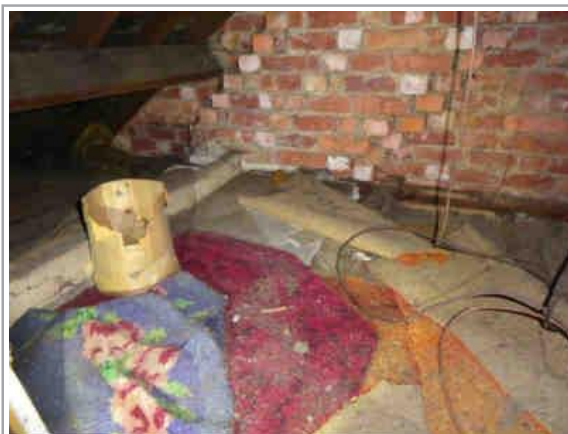
Carpet and other waste to be removed from roof space

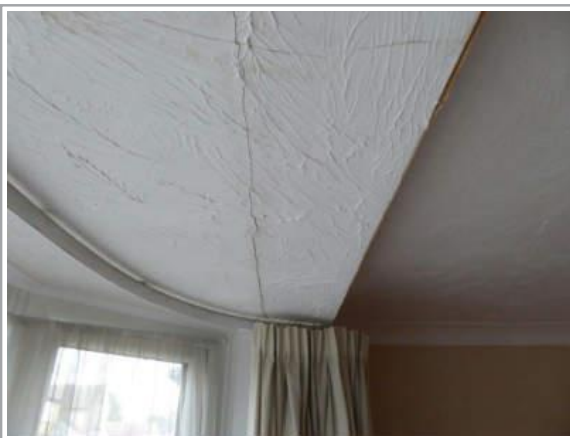
The ceiling to the sitting room bay window is cracked and damaged and in poor condition. Replacement of this is considered to be more than normal maintenance but not serious or urgent, **Condition Rating - 2**. The ceiling was tested with a moisture meter and was found to be dry.

Bay window ceiling cracked and damaged

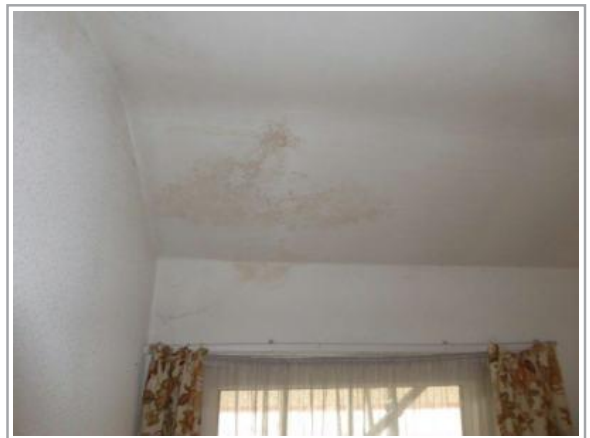
Localised water staining was noted to some first floor ceilings and this is attributable to recent rainwater penetration as detailed in D2: Roof Coverings and E1: Roof Structure, **Condition Rating - 1.**

Water stained ceiling due to water penetration

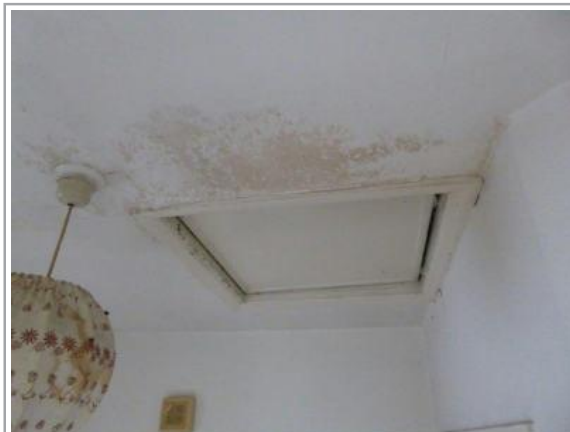
Stains due to rain water

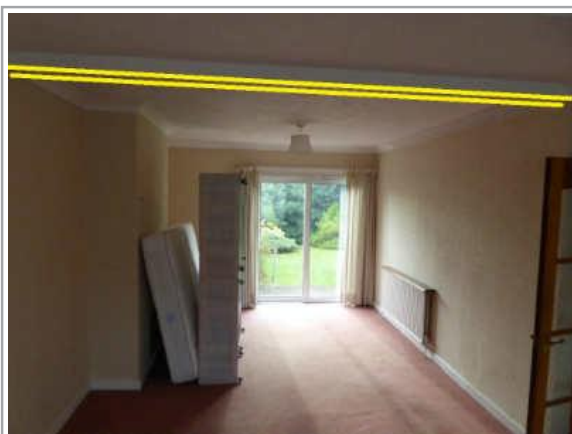
alteration appears to have been undertaken some time ago and there is no evidence of distress. I, therefore, have no concerns, **Condition Rating - 1.**

Wall removed between the two reception rooms

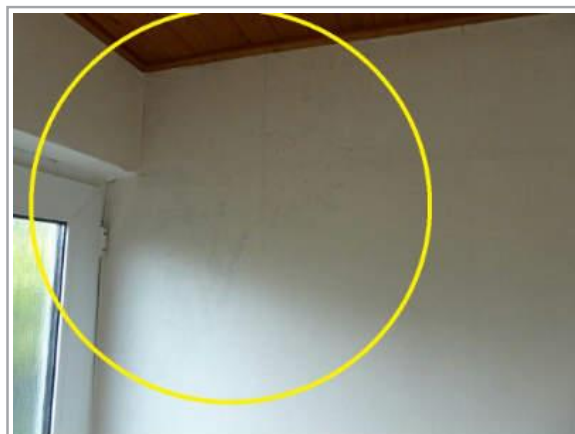
Water staining was evident to the inside right hand gable wall in the kitchen. This appears to be the result of historic leakage of an earlier soil and vent pipe which has consequently been replaced. This does not warrant further investigation, **Condition Rating - 1.**

Historic staining

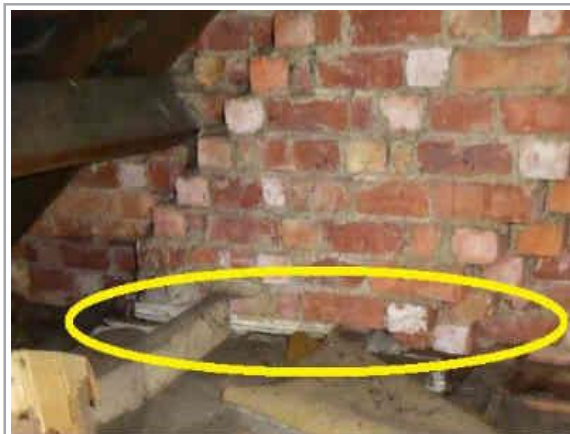
There is a chimney breast in the rear reception room which continues through to the bedroom above. The chimney breast in the sitting room and bedroom over have been removed. However, the brick flue (base of the stack) remains within the roof space. Although, this remaining section has been provided with a timber support this does not comply with current Building Regulations. You should consider seeking the advice of a competent building contractor with a view to providing an improved support system to comply with current Building Regulations. This is more than normal maintenance but is not considered to be either serious or urgent, **Condition Rating - 2.**

None standard support to flue above front bedroom

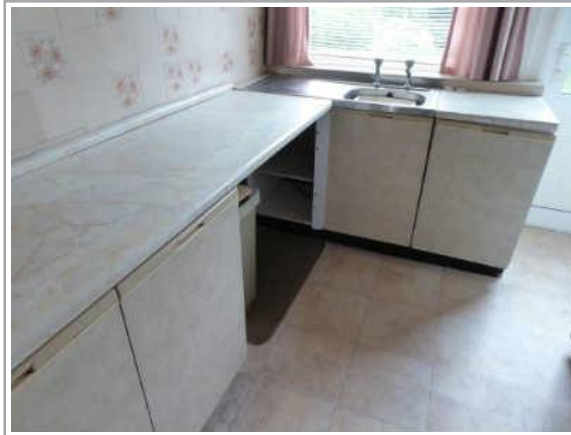
The kitchen is inadequately fitted with units which are dated.

The fittings are damaged and badly worn and replacement is required, **Condition Rating - 3.** You are advised to instruct a competent contractor to quote to replace the kitchen units in full.

Old kitchen units

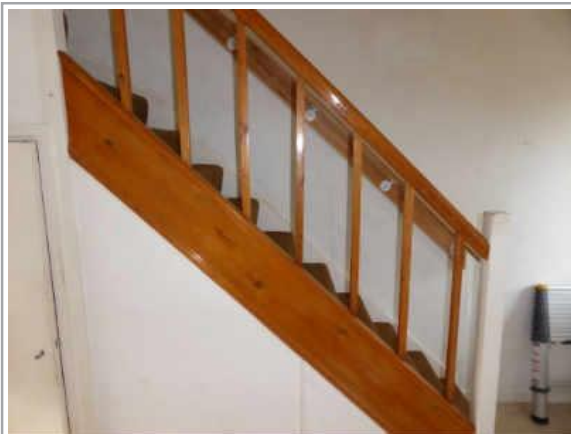
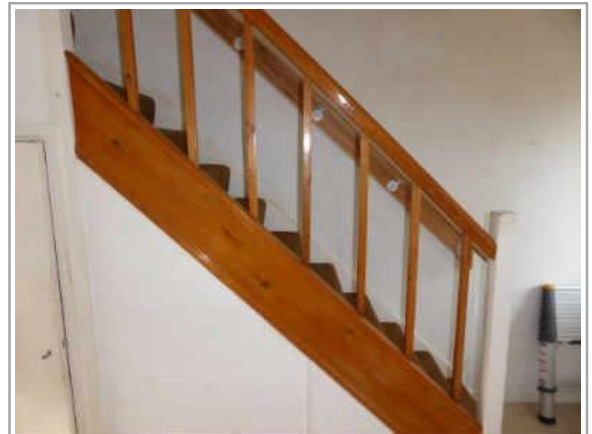
Some aspects of the staircase/balustrades are not to current standards, for instance the height of the balustrade and spacing between the spindles and, therefore, may present a safety hazard to young children. However, this is typical of a property of this age and there is no obligation upon you to remedy this situation but you should exercise care in using them. You must accept that older staircases will not be as safe as modern ones, please refer to section I: Risks, **Condition Rating - 3**.

Spindle spacing a risk to children & handrail height too low

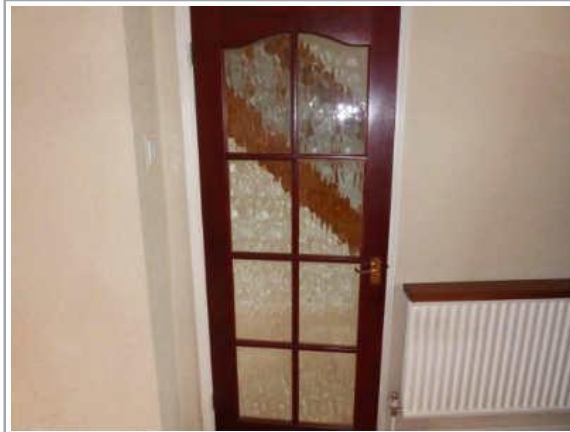
It was noted that some internal doors are fitted with glazing. This is unlikely to consist of toughened glass and, therefore, a safety hazard should people fall against it. Consideration should be given to having it replaced for safety reasons. Please see section I: Risks, **Condition Rating - 3**.

Probably non-dafety glazing to some internal doors

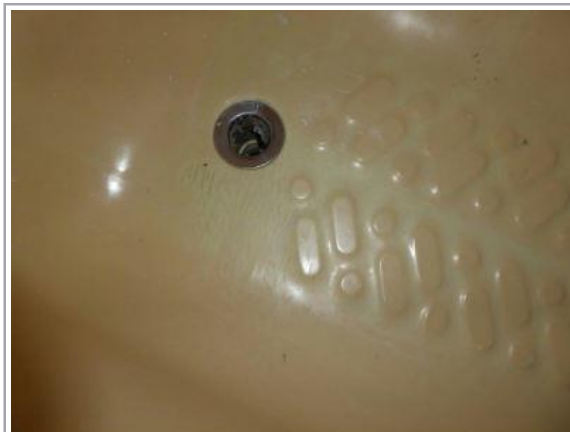
The fittings are worn and are due for replacement, **Condition Rating - 3.**

Old and worn bathroom suite due for replacement

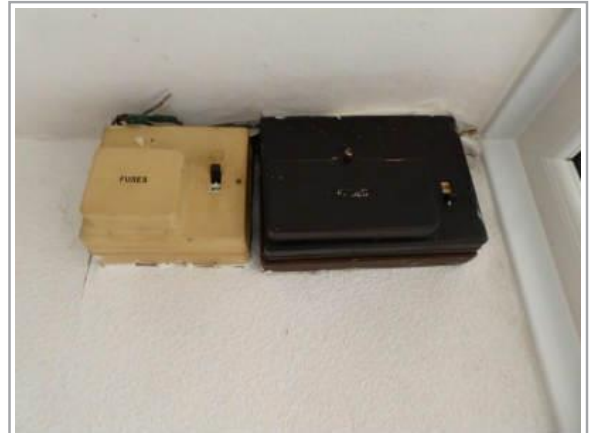
Surveyors are not specialists in this particular field. However, I noted a number of features such as dated and mixed fittings along with original consumer units that concern me. In addition, I saw no evidence that the system has been inspected or tested recently. It would be advisable to arrange for a test and visual examination of the electrical system to be undertaken by an 'authorised competent person' such as an NICEIC/NCA (<http://www.niceic.com/householder/find-a-contractor>) qualified electrician. This should be undertaken prior to your commitment to purchase, please see section I: Risks, **Condition Rating - 3.**

Original consumer units

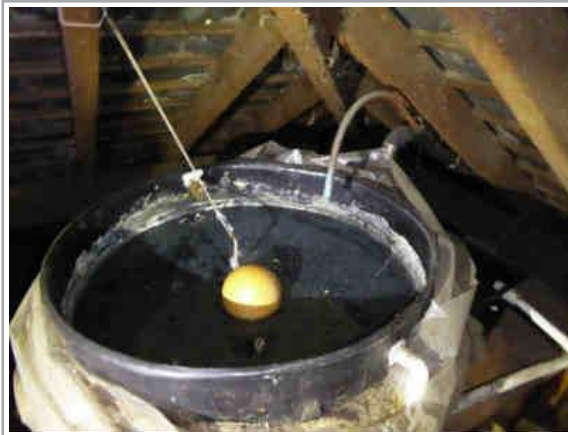
The cold water storage tank does not have a close fitting lid and this could allow debris to fall into the stored water. Consideration should be given to fitting an appropriate lid. This is considered to be urgent but not serious, please see section I: Risks, **Condition Rating - 3.**

The water storage tank and adjacent pipework is not insulated and could freeze during cold weather. The resulting leaks could damage the rest of the building. Consideration should be given to insulating these. This is considered to be urgent but not serious, please see section I: Risks, **Condition Rating - 3.**

Uncovered and poorly lagged cold water tank in loft

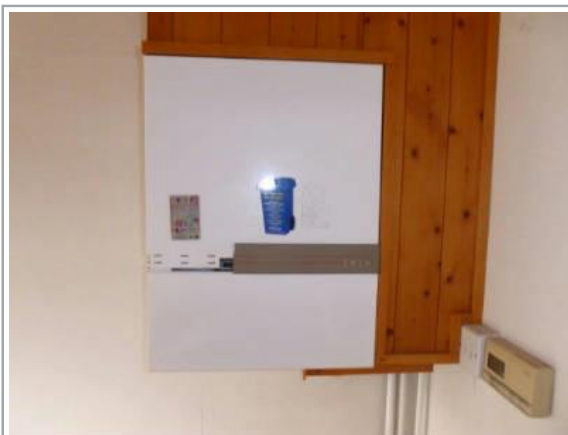
Surveyors are not specialists in this particular field. However, I am concerned regarding the advanced age of the boiler. The maintenance costs will increase over time and many boilers may need replacing after 10 to 15 years. This boiler is older than that and is likely to require replacement in the very near future. In addition I saw no evidence of regular servicing. You should ask a registered Gas Safe engineer to inspect the system prior to your commitment to purchase and you should not use the system until this has been done, please see Section I: Risks, **Condition Rating - 3.**

Old boiler

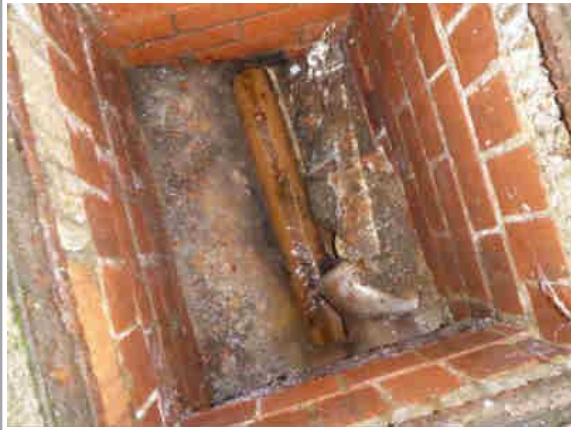
The covers of three of the three located inspection chambers were lifted, one of the chambers was found to be clear, another was found to be partially blocked and should be cleared and another requires minor repair to the haunching (mortar/concrete moulding at the base of the drain). This is considered to be more than normal maintenance but is not serious or urgent, **Condition Rating - 2.**

Minor repairs to haunching required

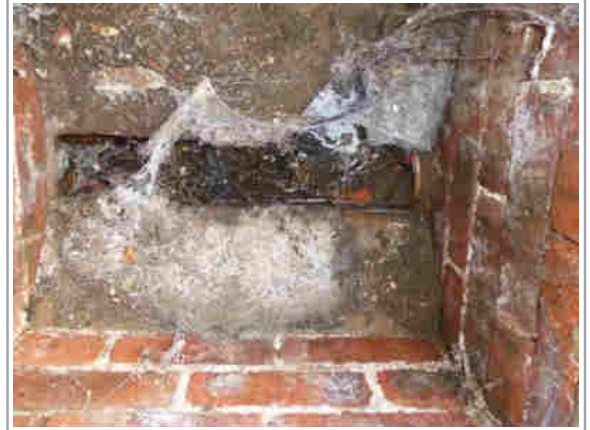
Partially blocked drain

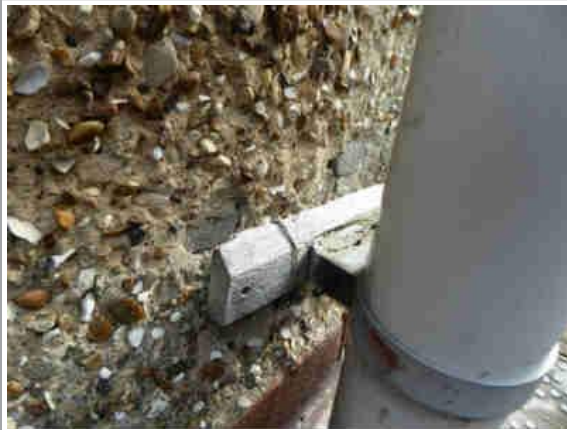
No serious defect or urgent repairs were observed but normal maintenance will be necessary, for instance the clamps that fasten the soil vent pipe to the wall require refixing, **Condition Rating - 1.**

Re-attach fixing brackets to soil & vent pipe

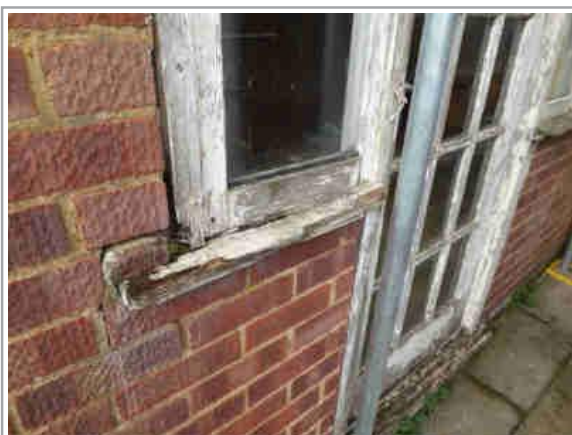
The garage is a basic structure below the standard of modern garages. I noted numerous defects namely; broken glass to the window, blown plaster due to damp, weathered pointing, water ingress due to the failed roof and wet rot affecting the windows and doors. Repairs/renewals are required, please see section I: Risks, **Condition Rating - 3.**

Considerable wet rot to woodwork

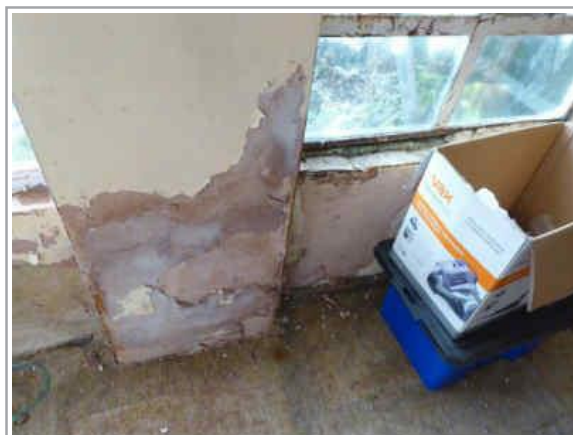
Damp issues and blown plaster

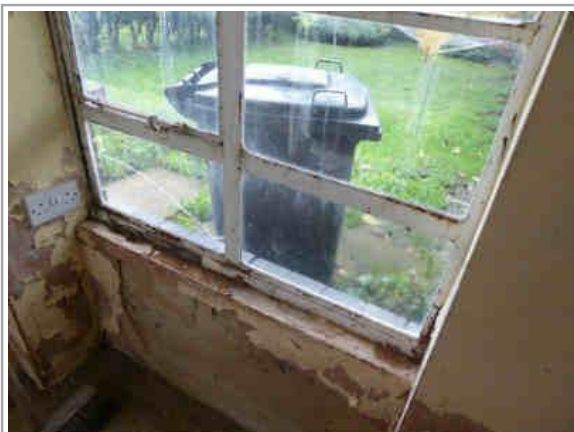
There are low level glazed windows with both broken glass and non safety glass. This glazing should be replaced with safety glass or generally made safe, **Condition Rating - 3.**

Low level and dangerous glazing

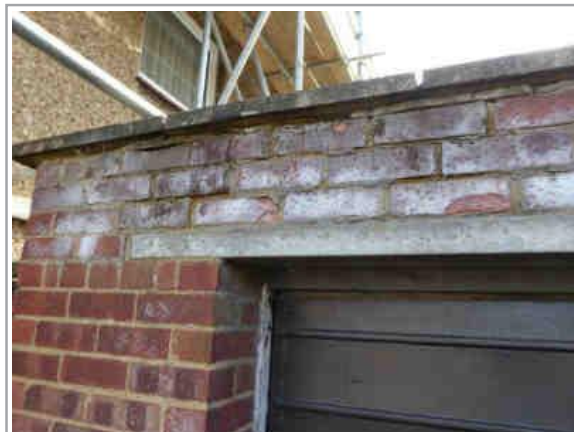
Widespread weathering of the brickwork and mortar between the bricks (called the pointing) has occurred and this has allowed dampness to get in to the building, you should repair this as soon as possible. This is considered to be more than normal maintenance but is not serious or urgent, **Condition Rating - 2.**

Considerable repointing required

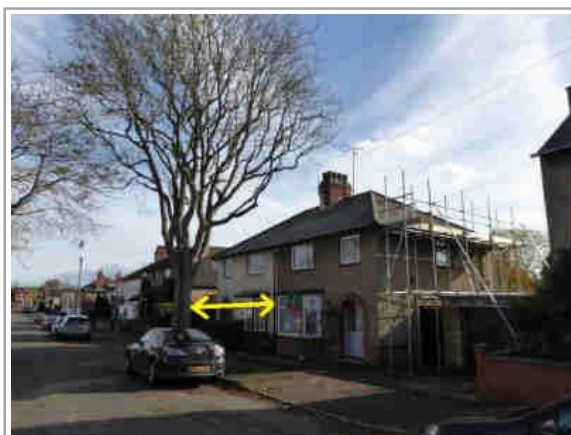
There is an ash tree close to the property, it is approximately 15 metres in height and some 4 metres from the bay window growing on Local Authority land. Whilst no associated damage was noted, trees can cause problems to structures and services located on shrinkable subsoils. The tree should be kept under strict control by regular lopping/pruning as has evidently already been the case, please see section I: Risks, **Condition Rating - 3**.

Large tree close to the property

You should ask your Legal Adviser to consider contacting the owner of the property on which the trees are located with a view to bringing their attention the potential risk caused by the trees and ask them to keep the trees under strict control by regular lopping/pruning.
