Your survey report

1 Any Road, Stamford, Lincolnshire, PE9 1AB

1st July 2022

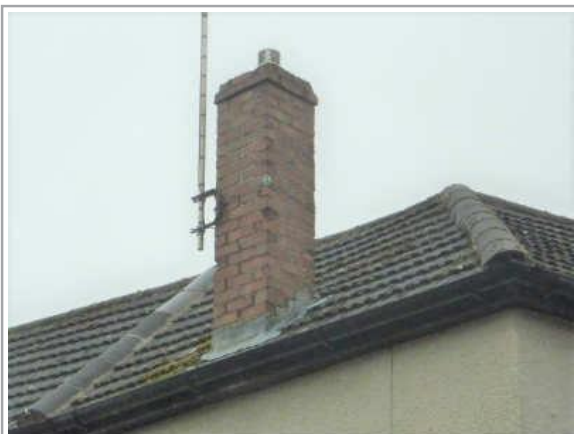
It was noted that water is penetrating the left hand chimney stack as this is evident high up against the chimney breast in bedroom 4. You are advised to instruct a competent building contractor to carry out further investigation by inspecting the left hand chimney stack to establish the condition and extent of any problems and make recommendations for any remedial measures necessary, please see section I: Risks, **Condition Rating - 3**.

Left stack

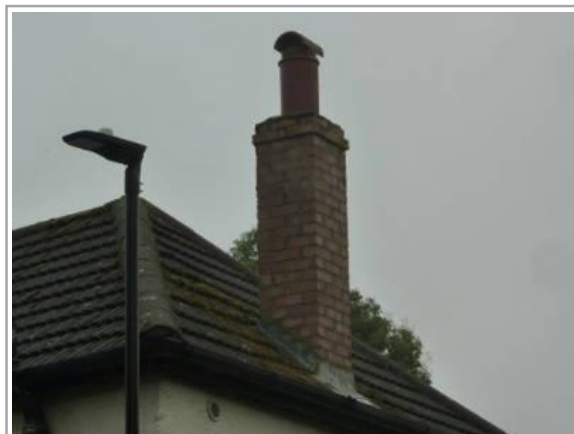
To the chimney stack to the right no serious defects or urgent repairs were observed but normal maintenance will be necessary, **Condition Rating - 1**.

Right stack

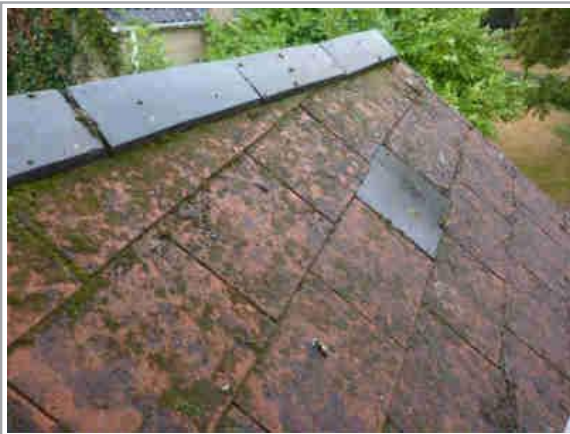
The utility room roof covering comprises tiles that may contain small amounts of asbestos fibres. These are not considered to be a risk to health in their present condition. However, if disturbed, they could become a safety hazard, **Condition Rating - 1**.

Utility room tiles

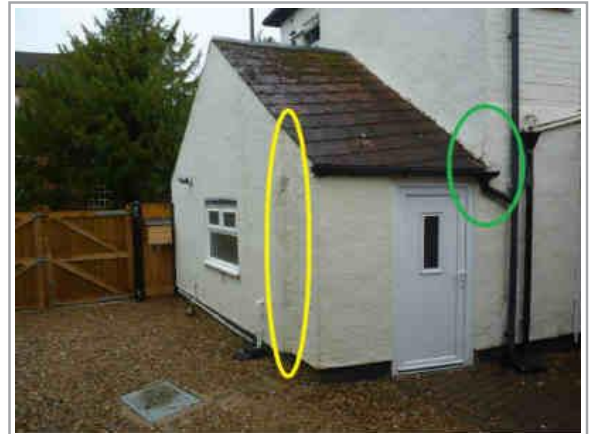
The tiles to the utility room do not overhang the gable end far enough to shed rainwater away from the wall. You could consider recovering this roof with a more suitable tile, perhaps matching the remainder of the building and providing a greater overhang to better weather the gable end in the long term. However, this condition has been in existence for many years with limited detriment to the

Limited verge detail leading to rainwater draining down the gable end

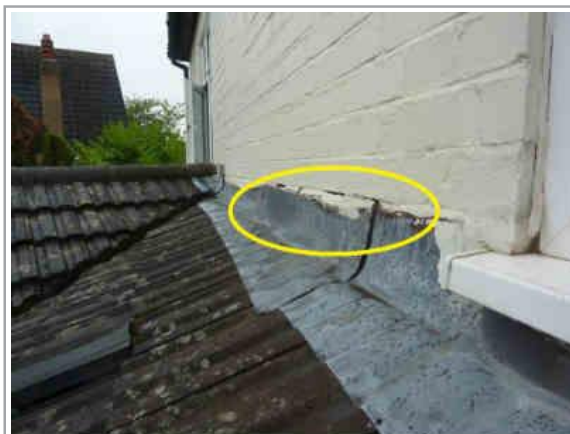
No serious defects or urgent repairs were observed. However, rebedding of the lead flashing at the junction of the single storey roof at the rear with the main rear wall is required. This is considered to be normal maintenance, **Condition Rating - 1.**

Minor re-bedding of lead flashing required

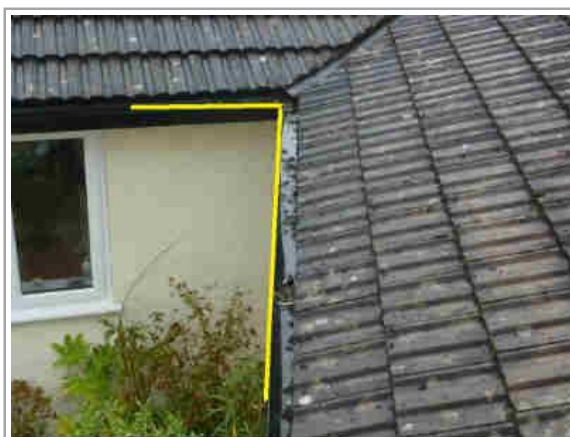
Although I saw no defects of a serious nature, normal maintenance of cleaning, resealing and re-aligning of the gutters is required, **Condition Rating - 1.**

Clean realign and reseal gutters

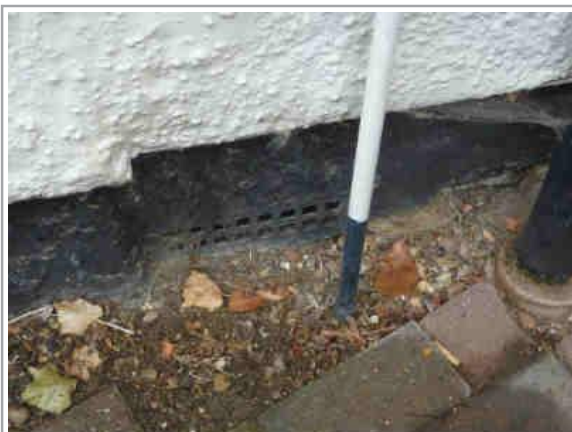
Where the ground floors are of solid construction there is no provision or requirement for sub floor ventilation. However, some floors are of suspended timber construction. Where timber floors are built into the main walls there is a potential for the timber to be in contact with dampness, consequently, it is standard practice to ventilate the area beneath the ground floors to reduce the risk of timber decay occurring. There are insufficient vents/air bricks to the base of the front and rear elevations of the original element of the building which are intended to provide ventilation to the sub-floor area beneath the dining room and lounge floors. This has been exacerbated by the single storey lean-to addition which has blocked any ventilation to the original rear walls. This is completely inadequate. Inadequate ventilation can lead to the decay of timber floors. The ventilation should be improved by the installation of additional vents, please see section I: Risks and refer to E4: Floors, **Condition Rating - 3.** This is a relatively simple task and one which a competent builder will be able to advise. An estimate/quote for the works should be obtained prior to your legal commitment to purchase.

Rear airbrick

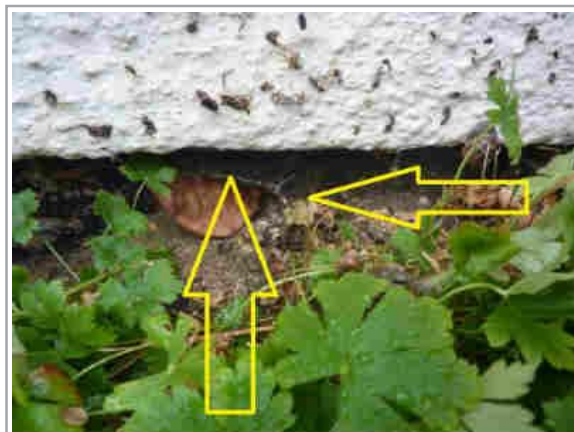
One of three located airbricks to the front elevation

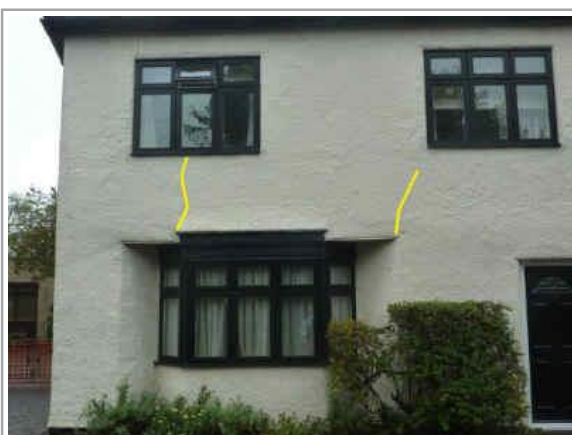
Minor deflection of lintel above sitting room window

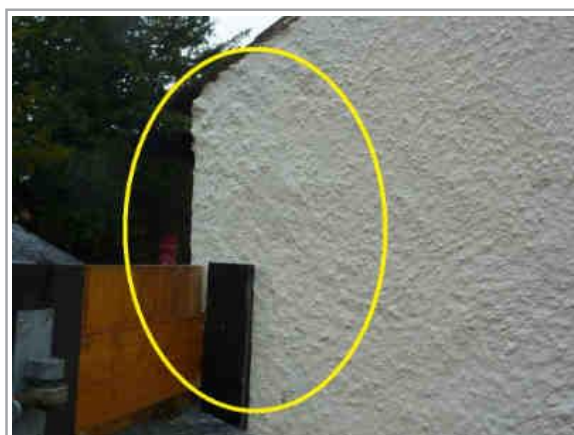
Hollow render to right of utility wall

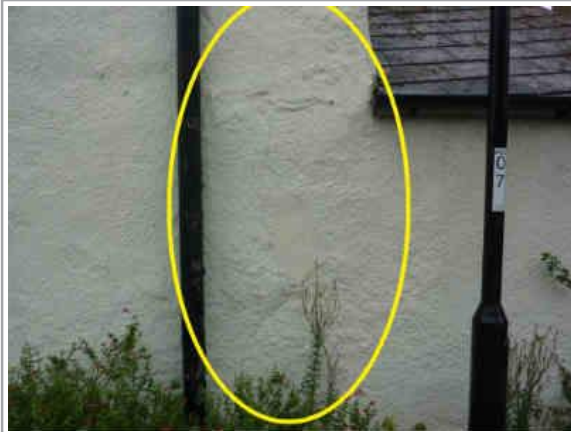
Parts of the render coating to the original two storey element of the building are cracked, loose and damaged. Defects in the render coating can allow the rain into the wall and in the worst case, cause dampness internally. Localised repairs are required. For the smaller cracks repair can take the form of a regular program of external redecoration, which will be required anyway for a building of this age. The larger areas of 'blown' render will require the render cutting out and reapplying with a lime based mix of mortar. This will be more flexible than the modern cement based render and allow the building to breathe. **Condition Rating - 2.**

Blown render to the front elevation

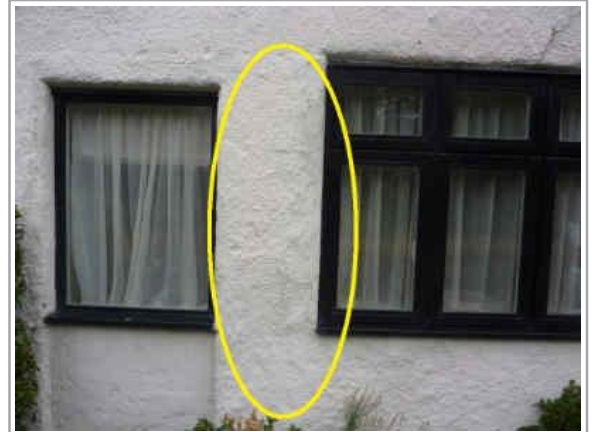
Repair to render required

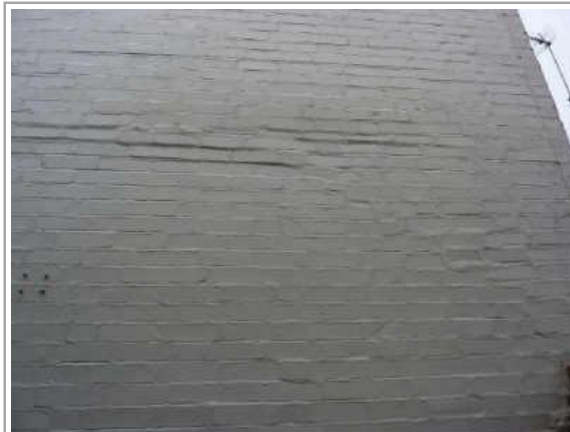
The solid brickwork to the rear can be seen to be of low grade workmanship with uneven coursing and minor bulges and irregularities. Repointing has helped to mask deficiencies in workmanship along previous alterations and movement. The property elevations have also been redecorated and this will have hidden any recent repairs that may have been undertaken. However, with this in mind, there appears to be no cause for concern in the brickwork. Normal maintenance will be required, **Condition Rating - 1.**

Repointed and painted brickwork masks previous alterations/movement and workmanship quality

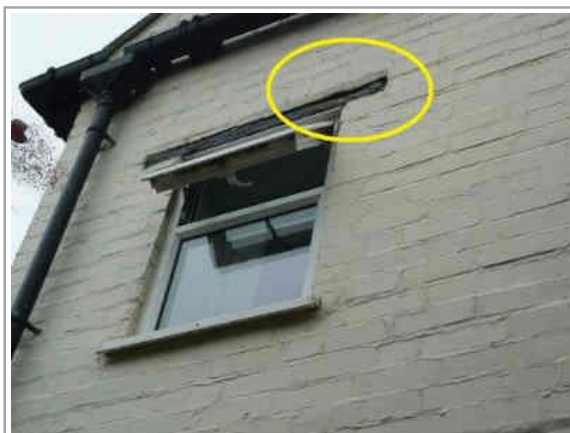
As to be expected with joinery of this age limited decay/deterioration exists and some repair is necessary which is considered to be normal maintenance, **Condition Rating - 1.**

Minor repair and redecoration of bedroom window lintel required

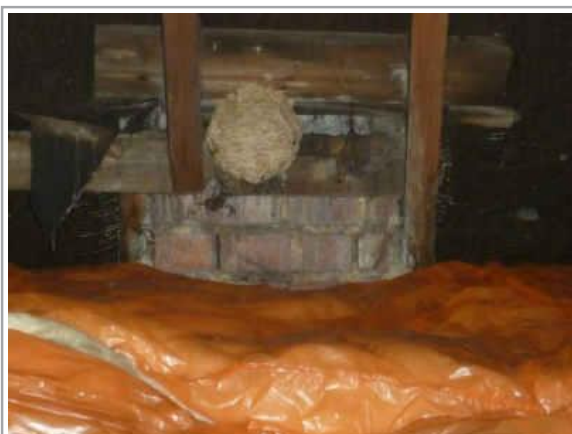
There is a wasp's nest in the roof space and it would be advisable to have it removed by a pest controller. **Condition Rating - 1.**

Active wasp nest in roof void

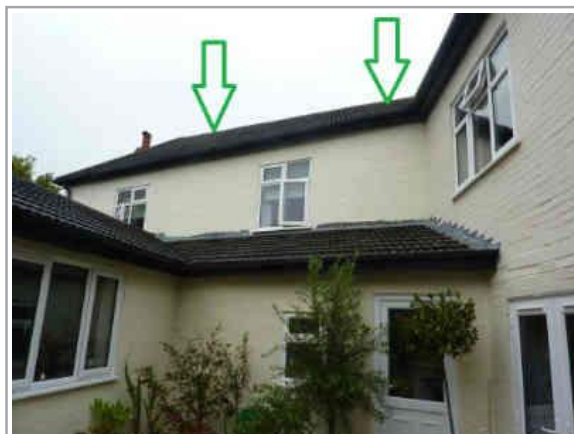
The immediate previous roof covering would have been a lighter weight slate covering and it is standard practice when replacing a slate covering with a heavier modern concrete tile covering, to strengthen the roof. This roof has now been strengthened, probably after the concrete tiles were introduced and again probably as a result of deflection that occurred to the original timbers but this is not untypical of roof structures of this age and is not considered to be serious. **Condition Rating - 1.**

Moderate deflection to roof timbers due to heavier roof covering

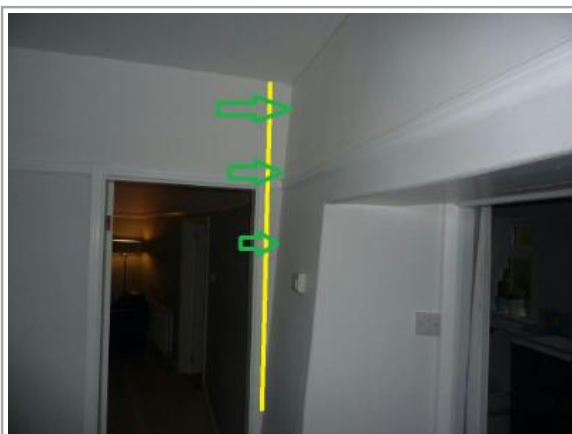
It is evident from an internal inspection of the external walls that the original rear wall to the cottages is out of true. This is concealed externally by the addition of the single storey lean-to extension. Such movement is fairly typical of properties this age and construction and appears to be longstanding and non-progressive and the likelihood of further significant movement seems remote. No structural repairs are considered necessary, **Condition Rating - 1.**

Ground floor original rear wall out of true

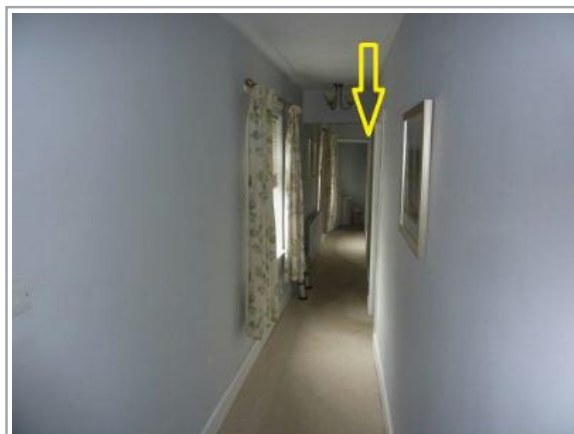
Some internal door frames were noted to be out of square. This is considered to have occurred in the

early 'bedding down' period of the building and is a minor defect which does not have any serious ongoing structural significance. **Condition Rating - 1.**

Sloping to some door tops

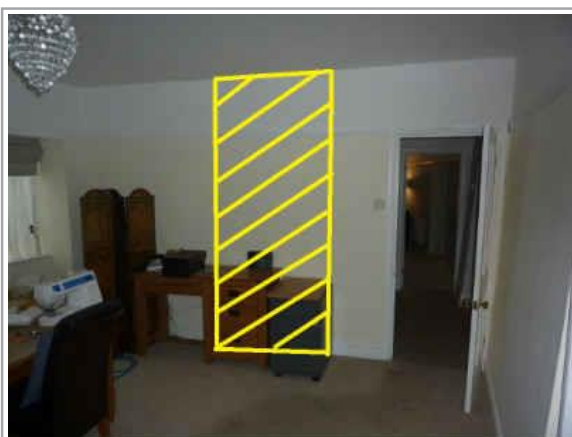
Site of removed chimney breast in dining room

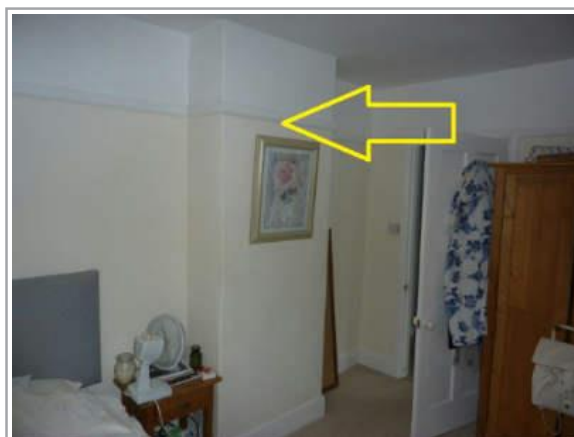
Chimney breast remains in bedroom 3 above

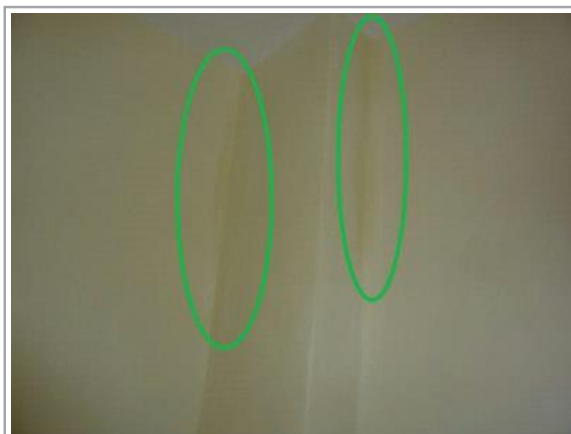
Note damp to chimney breast in bedroom 4, as previously detailed in D1: Chimney Stacks.

Damp to sitting room chimney breast showing in bedroom 4

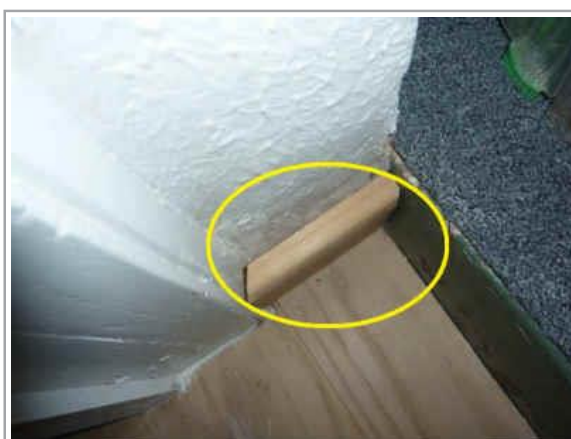
Internal woodwork has been maintained to a satisfactory standard, although some minor finishing works are required and this is considered to be normal maintenance, **Condition Rating - 1.**

Small section of skirting requires fixing to wall

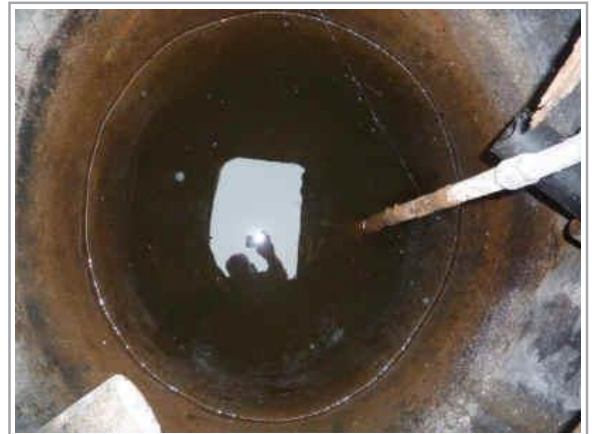
The remaining located inspection chamber was lifted and it was found to conceal a large below ground cistern/well. The cover is heavy duty and fixed firmly in place. However, it is as well to be aware of the existence of this below ground body of water. **Condition Rating - 1.**

Well/cistern below the drive

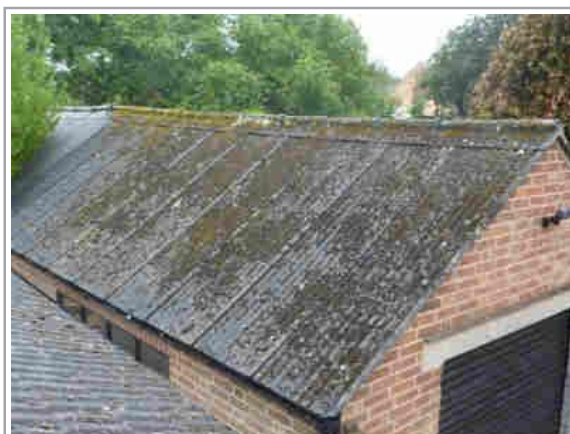
The roof covering is believed to contain material which may comprise asbestos fibres. This is not considered to be a risk in its present condition but if disturbed, it could be a safety hazard, **Condition Rating - 1.**

Garage roof

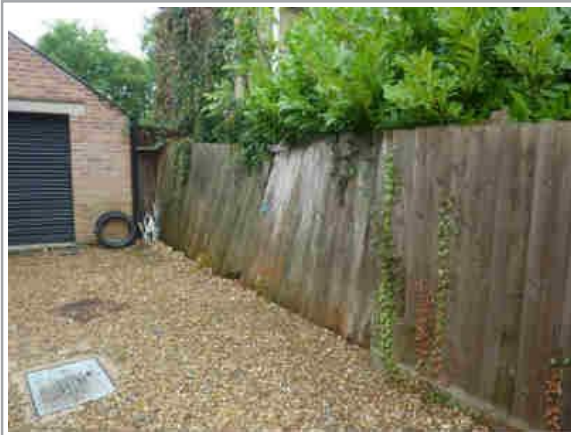
Section of timber fence in poor condition

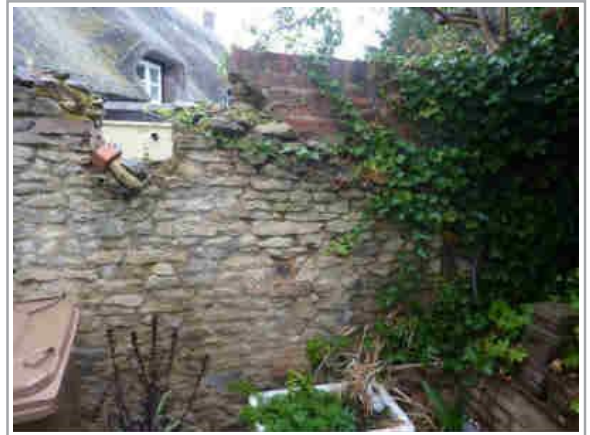
Basic repairs to stone & brick wall required
