Your survey and valuation report

100 Any Avenue, Northampton, Northants, NN10 1AB

1st July 2022

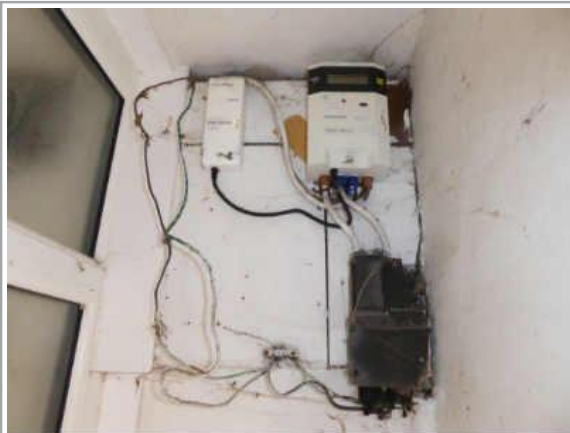
Electric meter

Surveyors are not specialists in this particular field. However, I noted a number of features such as dated and mixed fittings along with original consumer units that concern me. In addition, I saw no evidence that the system has been inspected or tested recently. It would be advisable to arrange for a test and visual examination of the electrical system to be undertaken by an 'authorised competent person' such as an NICEIC/NCA (<http://www.niceic.com/householder/find-a-contractor>) qualified electrician. This should be undertaken prior to your commitment to purchase, please see section I: Risks, **Condition Rating - 3.**

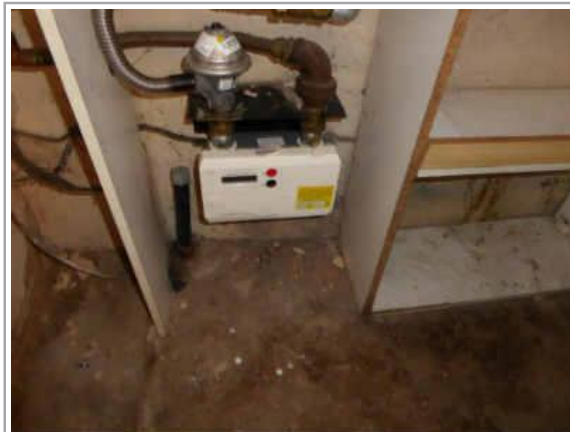
Gas meter to understairs cupboard

Surveyors are not specialists in this particular field. However, I noted an old and damaged gas fire in the garage and that concerned me. In addition, I saw no evidence that the system has been inspected or checked recently. It would be advisable to arrange for a gas safety check of the gas installation/appliances to be undertaken by a registered Gas Safe engineer. This should be undertaken prior to your commitment to purchase, please see section I: Risks, **Condition Rating - 3.**

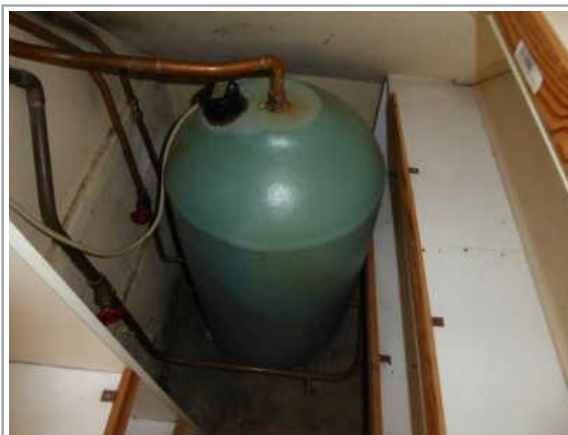
Hot water cylinder in under stairs cupboard

Surveyors are not specialists in this particular field. Although I saw no features that concern me I saw no evidence to confirm that the system has been recently serviced. You should ask a registered Gas Safe engineer to inspect the system prior to your commitment to purchase and you should not use the system until this has been done, please see section I: Risks, **Condition Rating - 3.**

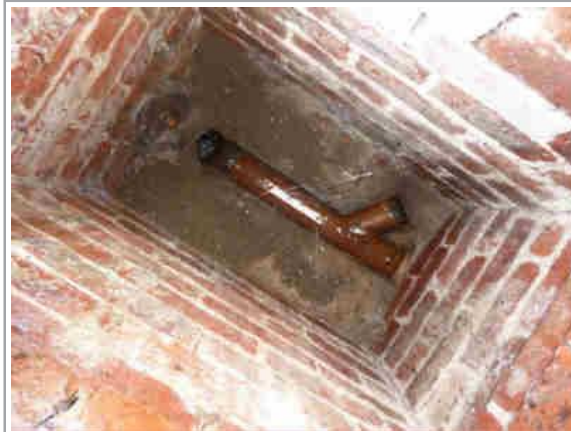
Clear chamber
