Your survey report

1 Any Road, Stamford, Lincolnshire, PE9 1AB

1st July 2022

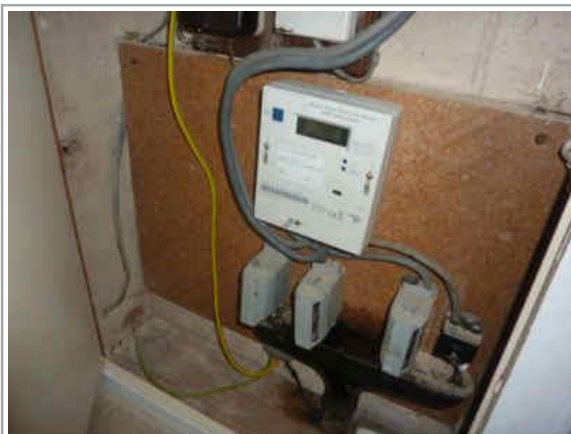
Electricity meter

Recent alterations are evident to the electrical system in the form of the refitted kitchen and bathrooms. Your Legal Adviser should be requested to obtain confirmation that these changes have been undertaken by an 'authorised competent person' such as a NICEIC/NCA (<http://www.niceic.com/householder/find-a-contractor>) qualified electrician and that the installation complies with current Building Regulations, please see section H: Issues For Your Legal Adviser and section I: Risks, **Condition Rating - 3.**

Surveyors are not specialists in this particular field. Although, I could see no features that concerned me I did not see any evidence that the electrical system has been inspected/tested recently. I, therefore, recommend that this should be done prior to your commitment to purchase, please see section I: Risks, **Condition Rating - 3.**

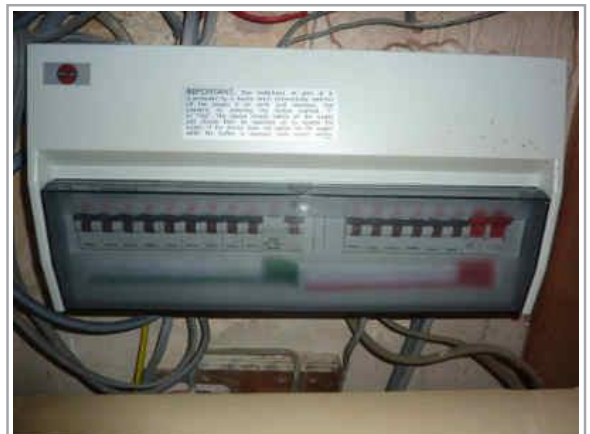
Upgraded consumer unit

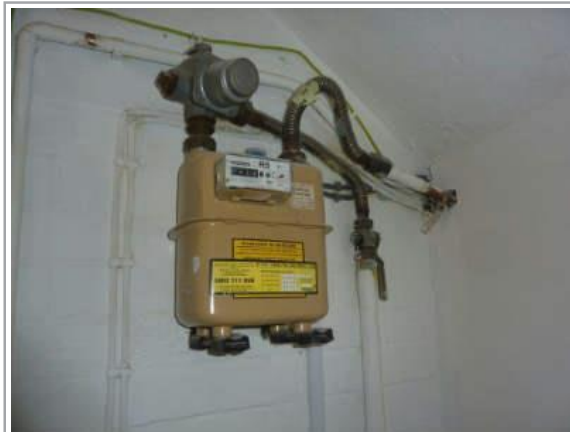
Gas meter

Surveyors are not specialists in this particular field. Although, I could see no problems with the gas appliances/installation I saw no evidence to confirm recent safety checks/tests have been undertaken. You should ask a registered Gas Safe engineer to inspect the system prior to your commitment to purchase, please see section I: Risks, **Condition Rating - 3.**

There are no visible carbon monoxide detectors. Consideration should be given to having these fitted, see section I: Risks, **Condition Rating - 3.**

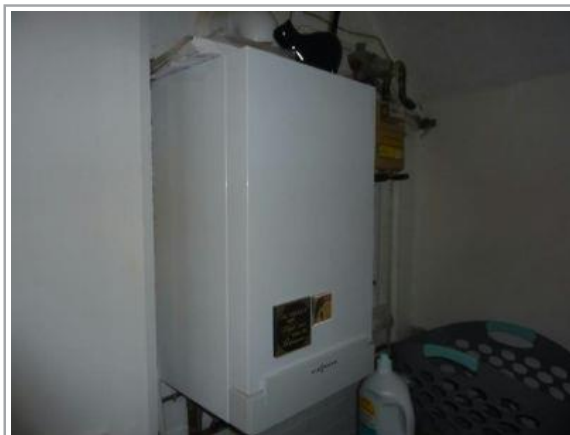
A regular gas boiler in the utility room provides domestic hot water and heats a system of panel radiators located in most main rooms. 3

Surveyors are not specialists in this particular field. Although I saw no features that concern me I saw no evidence to confirm that the system has been recently serviced. You should ask a registered Gas Safe engineer to inspect the system prior to your commitment to purchase and you should not use the system until this has been done, please see section I: Risks, **Condition Rating - 3.**

Gas boiler in utility room

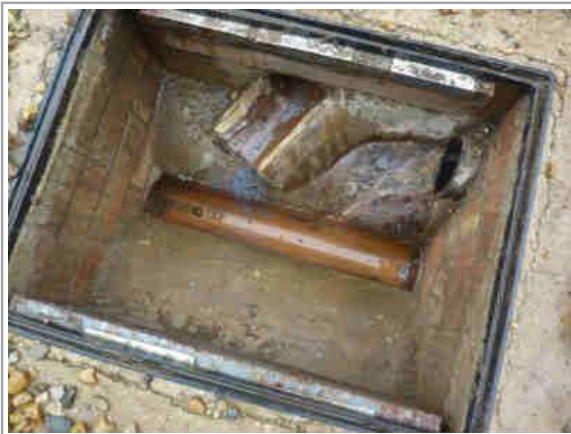
The remaining located inspection chamber was lifted and it was found to conceal a large below ground cistern/well. The cover is heavy duty and fixed firmly in place. However, it is as well to be aware of the existence of this below ground body of water. **Condition Rating - 1.**

Clear drains
